### CONSOLIDATED SEWER MAINTENANCE DISTRICT CONDITION ASSESSMENT PROGRAM REPORT – CITY OF SAN DIMAS

**CONDITION ASSESSMENT REPORT**  
**COUNTY OF LOS ANGELES DEPARTMENT OF PUBLIC WORKS**  
**CONSOLIDATED SEWER MAINTENANCE DISTRICT**

PROJECT NAME:	Y0TV1112B	PROJECT MGR:	Hanna Kebede
PROJECT DATE:	07/17/13	CONTACT NO:	(626) 300-4686
SUP. DISTRICT(s):	5	MAP PAGE(S):	2343, 2385, 2386, 2387
Report By:	Hanna Kebede	Report Date:	5/1/17

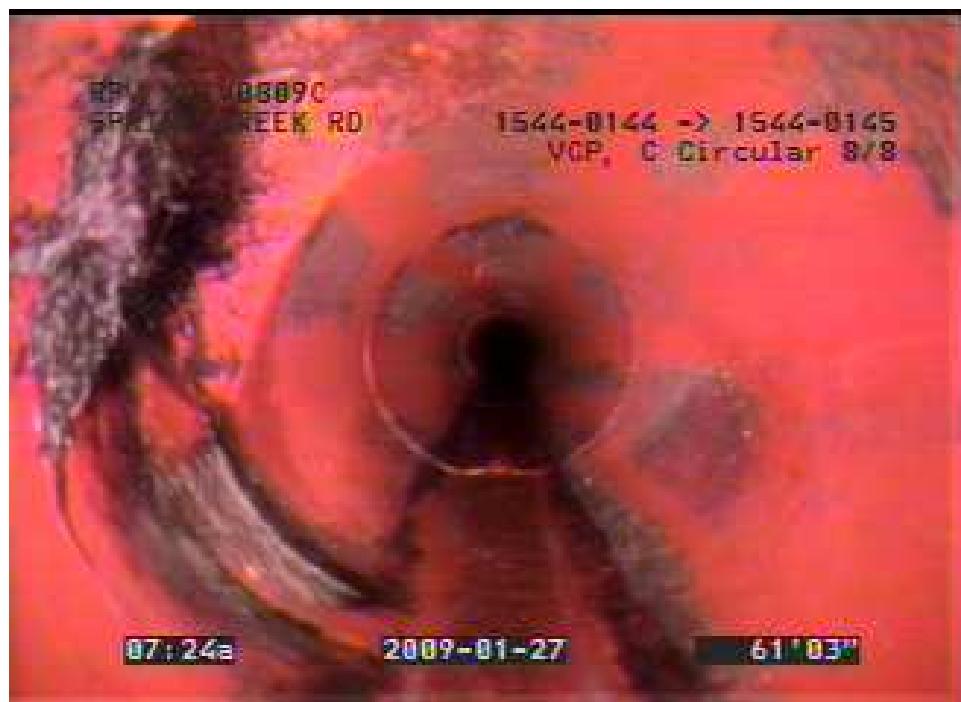
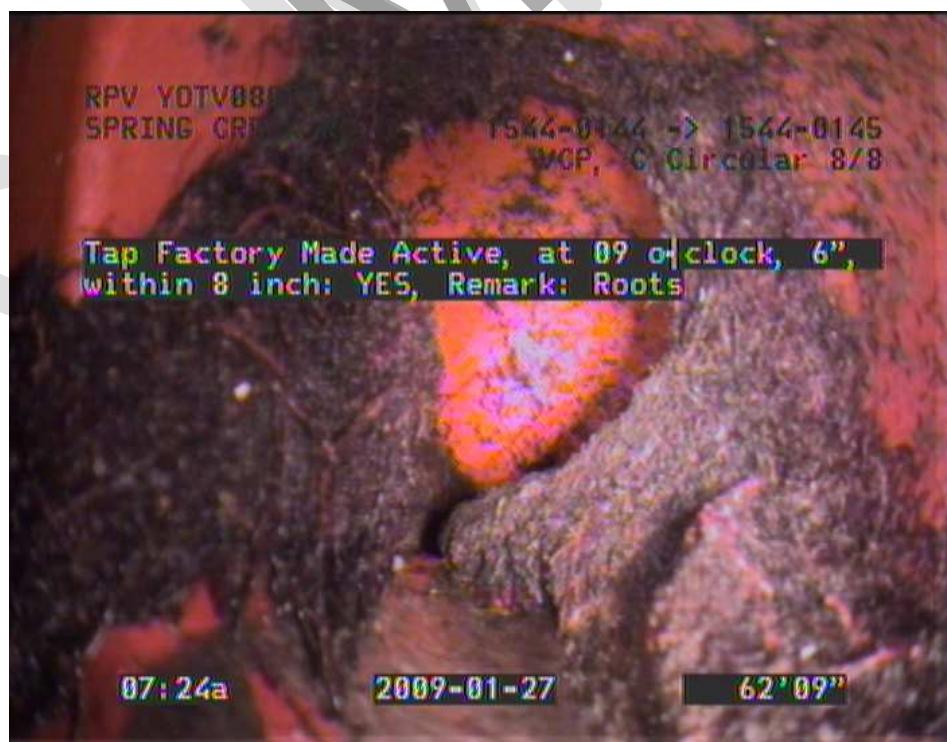
**XXXX**  
Roots at Lateral Connection

Since the CCTV inspection, the sewer mainline has been cleaned and blockages from root growth have been removed; however, the root blockage in your sewer lateral is still present. As the property owner, you are responsible for the entire length of the sewer lateral, which includes the portion that extends beyond the property line into the public right of way. We request that you contact a qualified plumbing contractor to service your sewer lateral within 90 days to remove roots and any other obstructions that may cause a sewage backup.

For your reference, we have enclosed photos of your lateral connection showing the presence of the root blockage. Also enclosed are some literature on ways of minimizing sewer overflows and damage to your home.
